**National Highway  
Traffic Safety  
Administration**

Case Vehicle (A): 1999 Volkswagen  
Type: Jetta, 4-door sedan  
Driver: 32-year-old male  
CDC: 06-BDEW-7, 01-FDEW-3

Vehicle (B): 1998 Dodge  
Type: Ram 1500, 4x4 pickup  
Driver: 27-year-old female  
CDC: 99-0000-0

Vehicle (C): 2001 Dodge  
Type: Dakota, 4x4 pickup  
Driver: 35-year-old female  
CDC: 99-0000-0

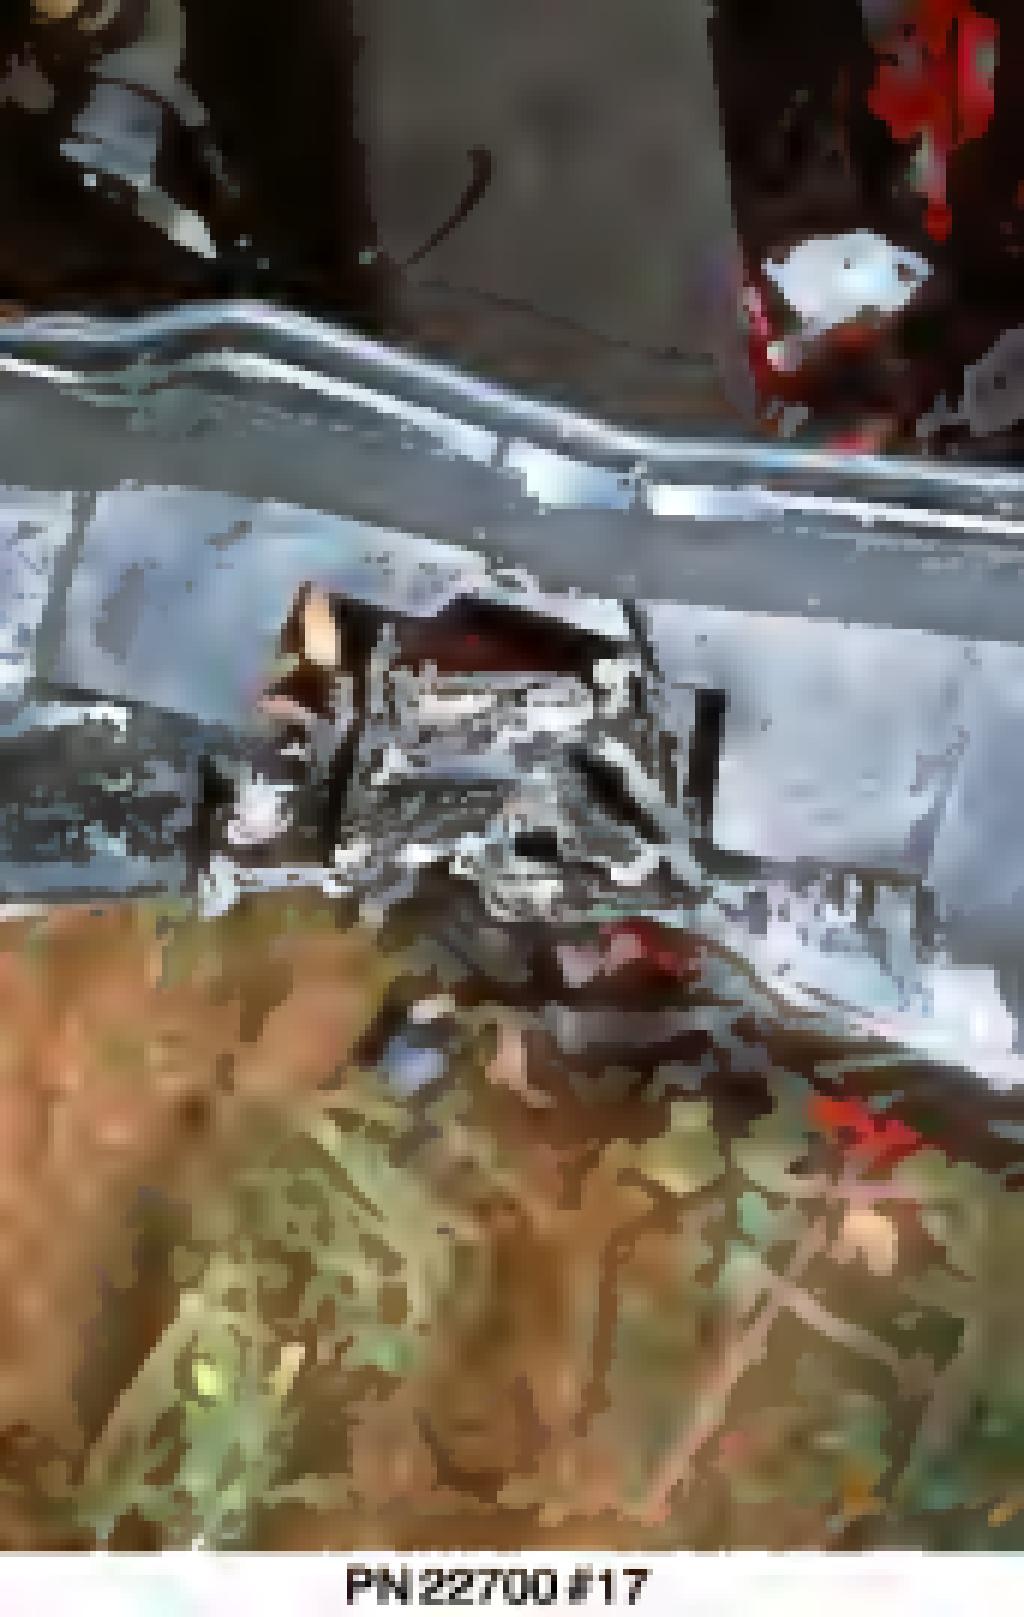
PN 22700 #16

(Slides 9, 10, 11, 12, 13, 14, 15) The front bumper, both headlight assemblies, the grille, and the radiator were severely crushed from the impact with vehicle (B). (Slide 16) The hood was crushed and elevated and contacted the windshield, but did not penetrate it. (Slides 17, 18) The hood latch was damaged and released. Both hood hinges were damaged. The windshield was cracked by the stress of impact forces. The right fender was buckled and the left fender was severely buckled. Both front doors remained closed and operational. Both rear doors were jammed shut. All of the wheel struts were damaged. Both quarter-panels were severely buckled. The roof was buckled and the left upper A-pillar was deformed, as a result of the deformation of both of the C-pillars and both rear roof siderails. The back bumper, both taillight assemblies and the trunk lid were severely crushed from the rear impact by vehicle (C).
